# Debris/Ice/TPS Assessment and Integrated Photographic Analysis of Shuttle Mission STS-71

*Gregory N. Katnik, Barry C. Bowen, J. Bradley Davis*

**27 June 1995**

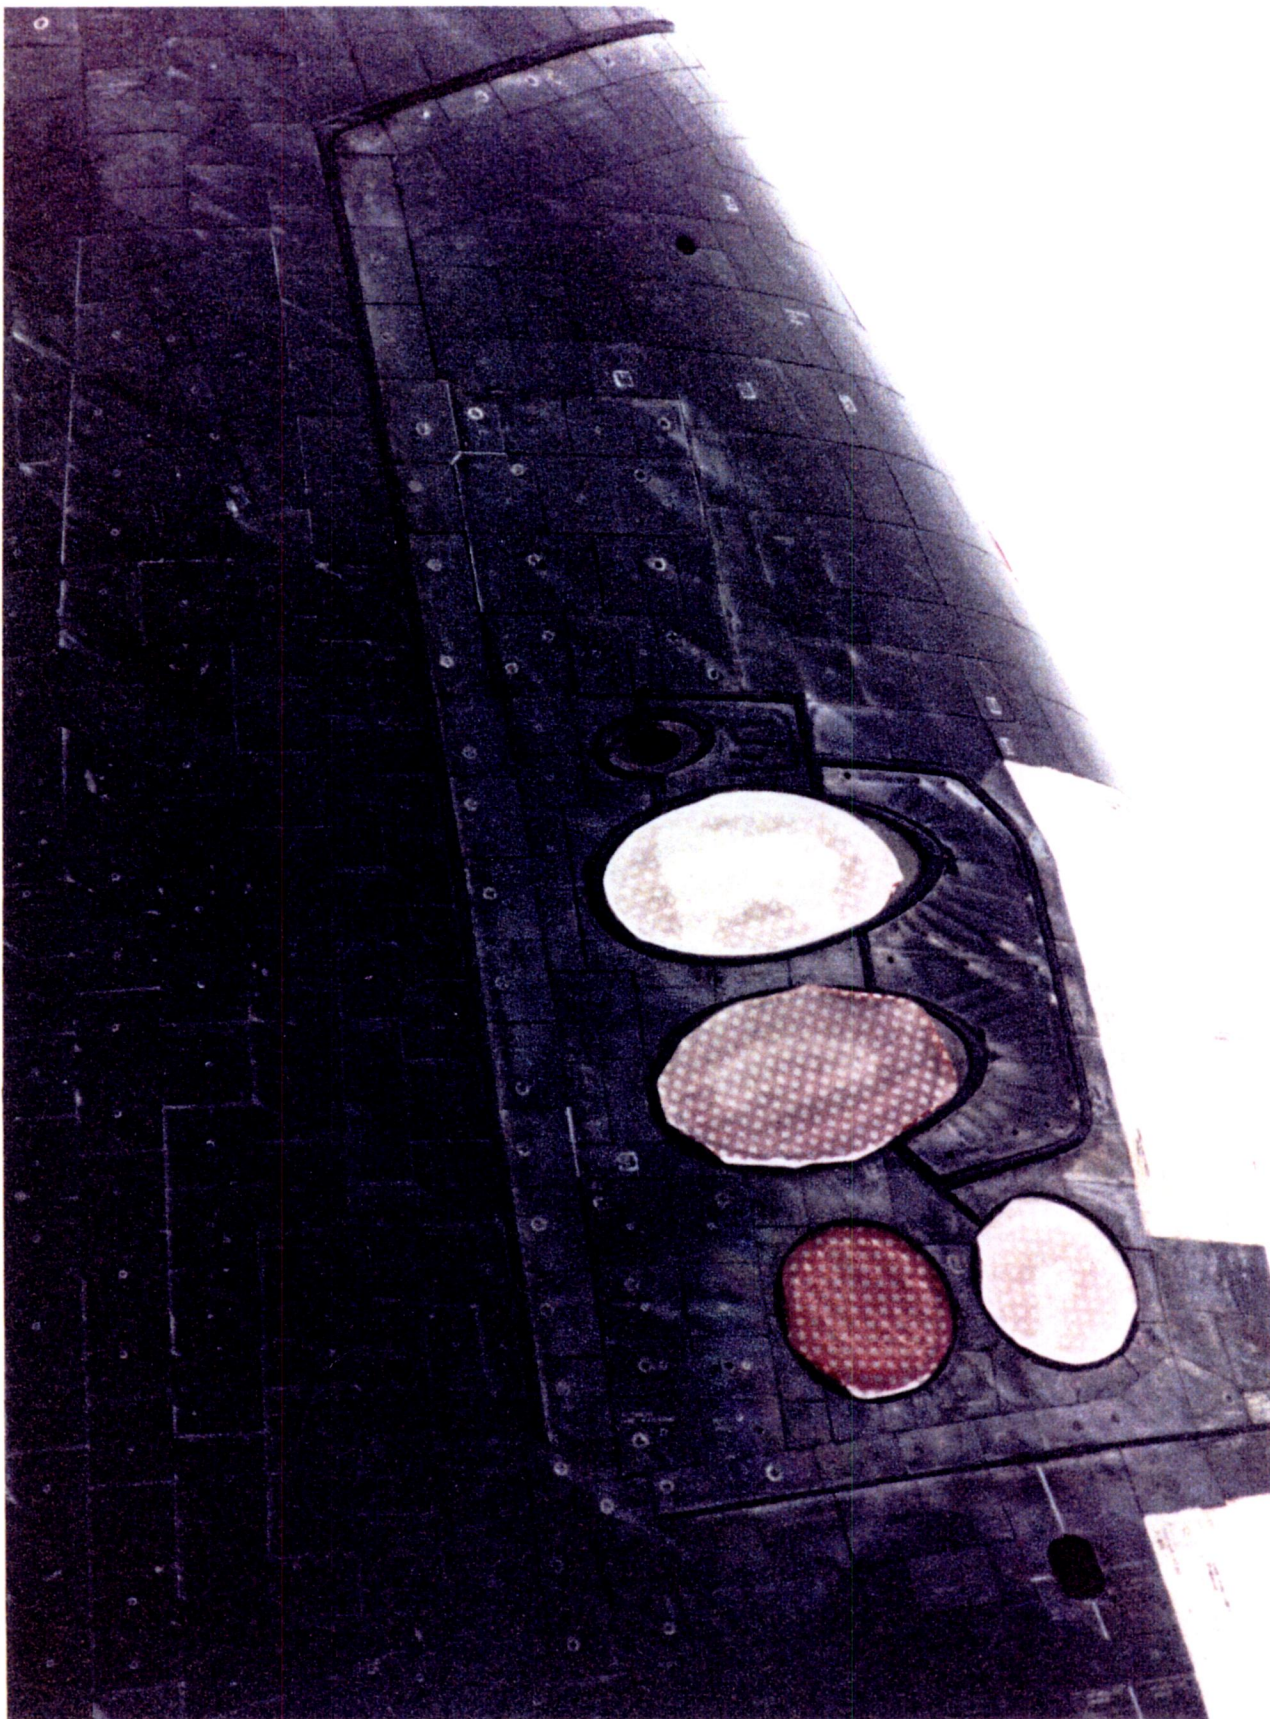
**Photo 3 : Forward RCS Thruster Covers**

View of wet FRCS thruster paper covers during first launch attempt. Note difference between dark F3L cover, indicative of a slight internal vapor leak, and the lighter F3D cover wetted by recent rainfall.

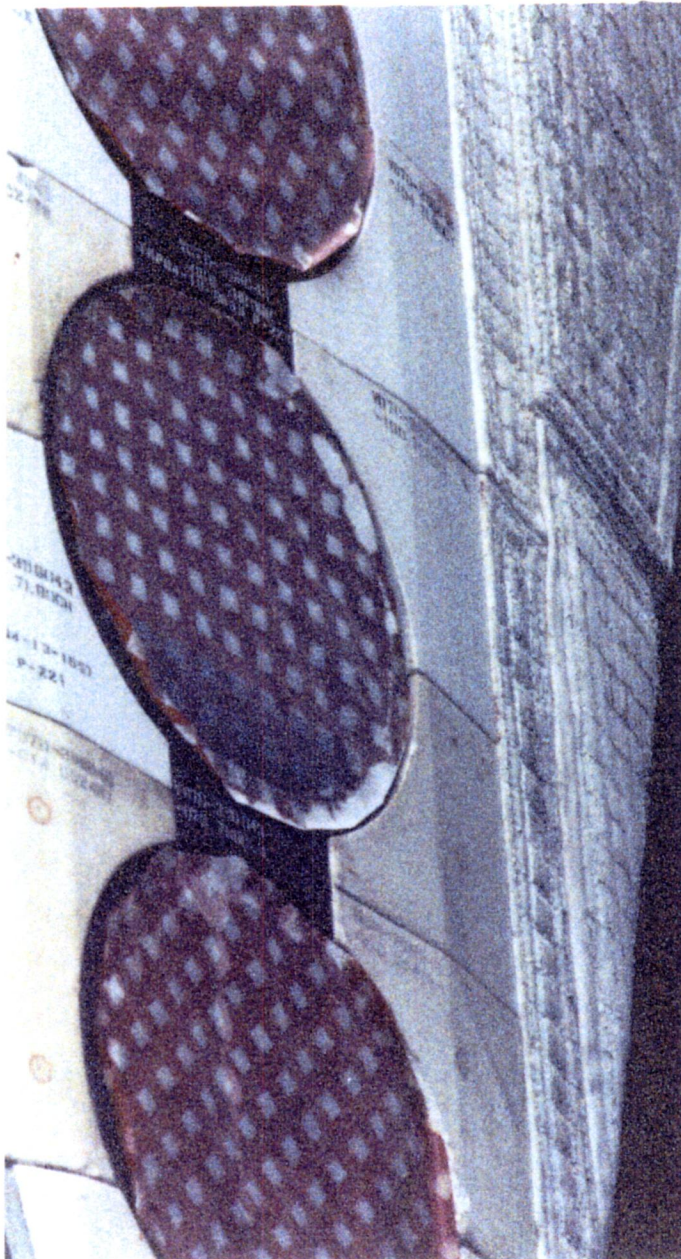
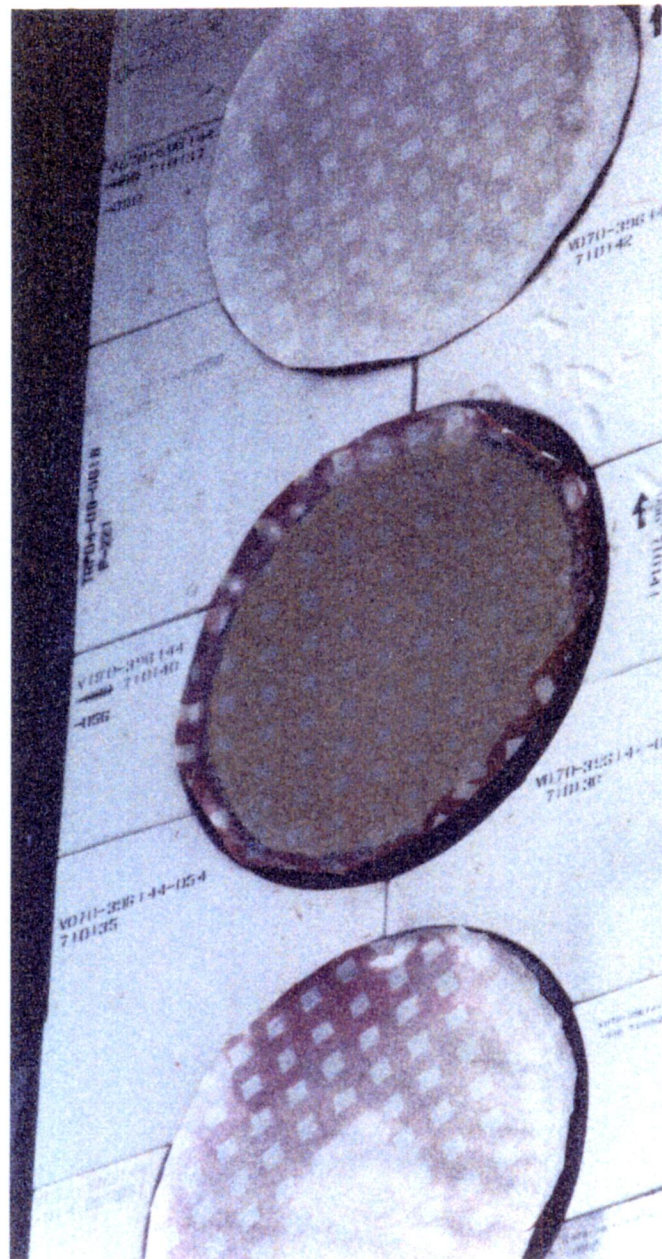
**Photo 4 : Aft RCS Thruster Covers**

The only anomaly on the Orbiter consisted of a visible liquid level line (approximately 25 percent of the nozzle diameter) on aft RCS thruster R3R. This water intrusion was the result of recent heavy rain on the pad. Paper covers on the L4D and R2U thrusters were tinted green, which is indicative of a slight internal vapor leak.

Liquid, most likely water from recent heavy rain on the pad, was visible behind aft RCS thruster R3R. Paper covers on the L4D and R2U thrusters were tinted green, which is indicative of a slight vapor leak. These conditions were noted during the first launch attempt.

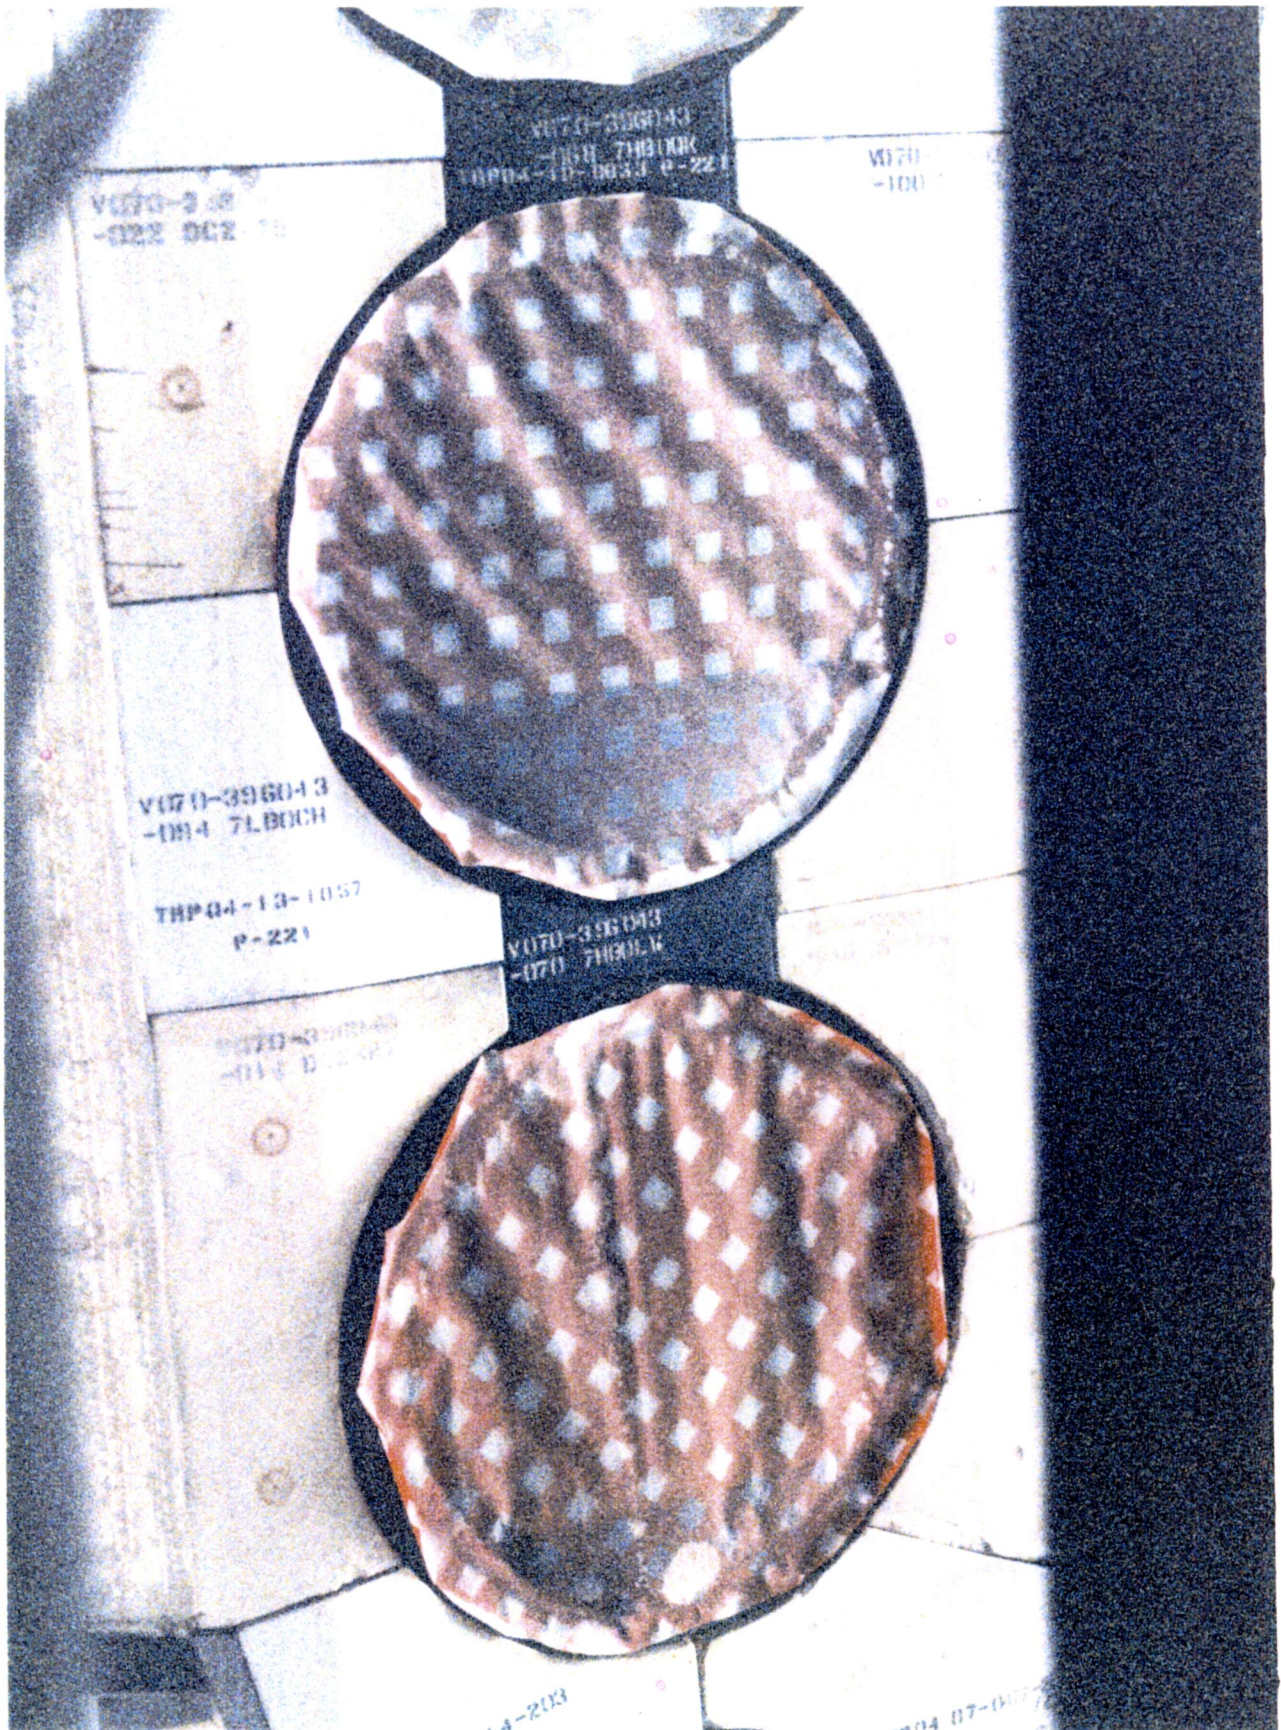
**Photo 5 : Post Drain Inspection of RCS Covers**

Close-in view of rain water trapped behind aft RCS paper covers. Water was removed and new covers installed during scrub turnaround.

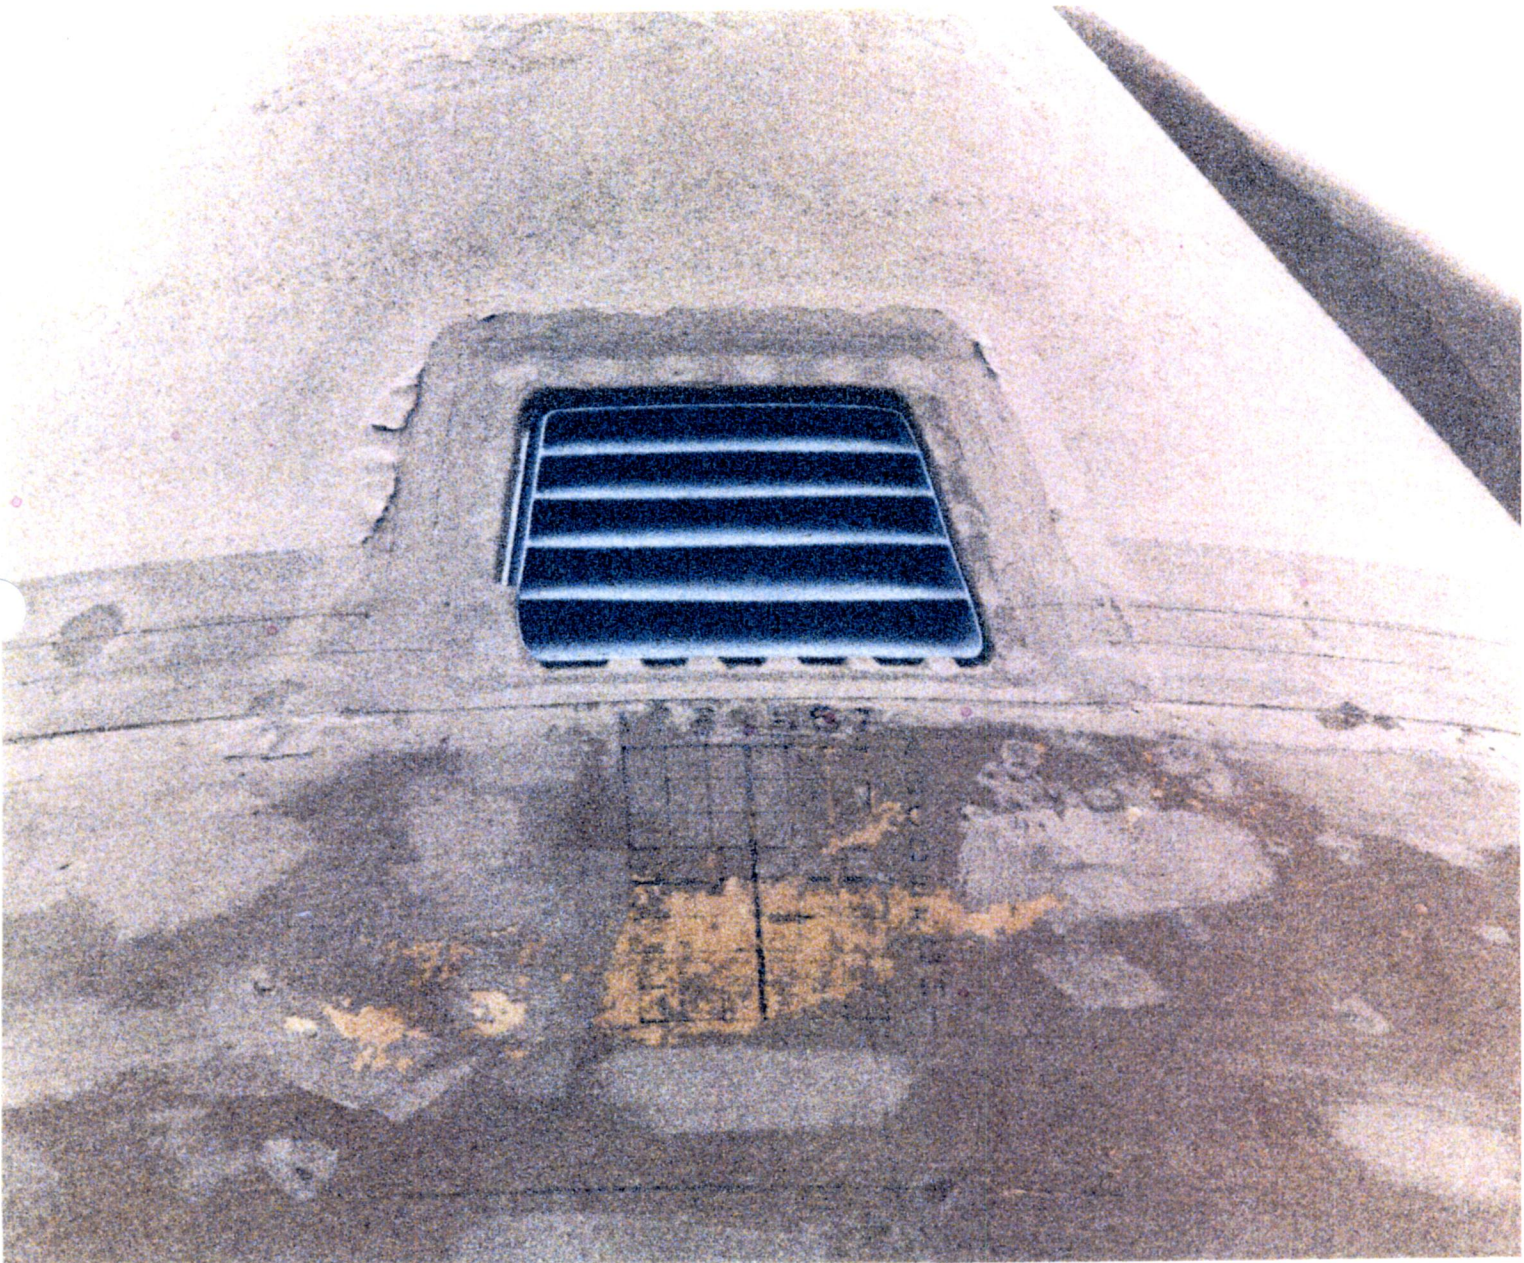
**Photo 7 : Post Drain Condition of ET Nose Cone Area**

Topcoat was loose/missing from the lower half of the -Y alignment grid and around the vent louver. The redesigned bipod jack pad closeouts were intact and flush with adjacent foam.

Topcoat was missing from the lower half of the alignment grid and peeled around the vent louver

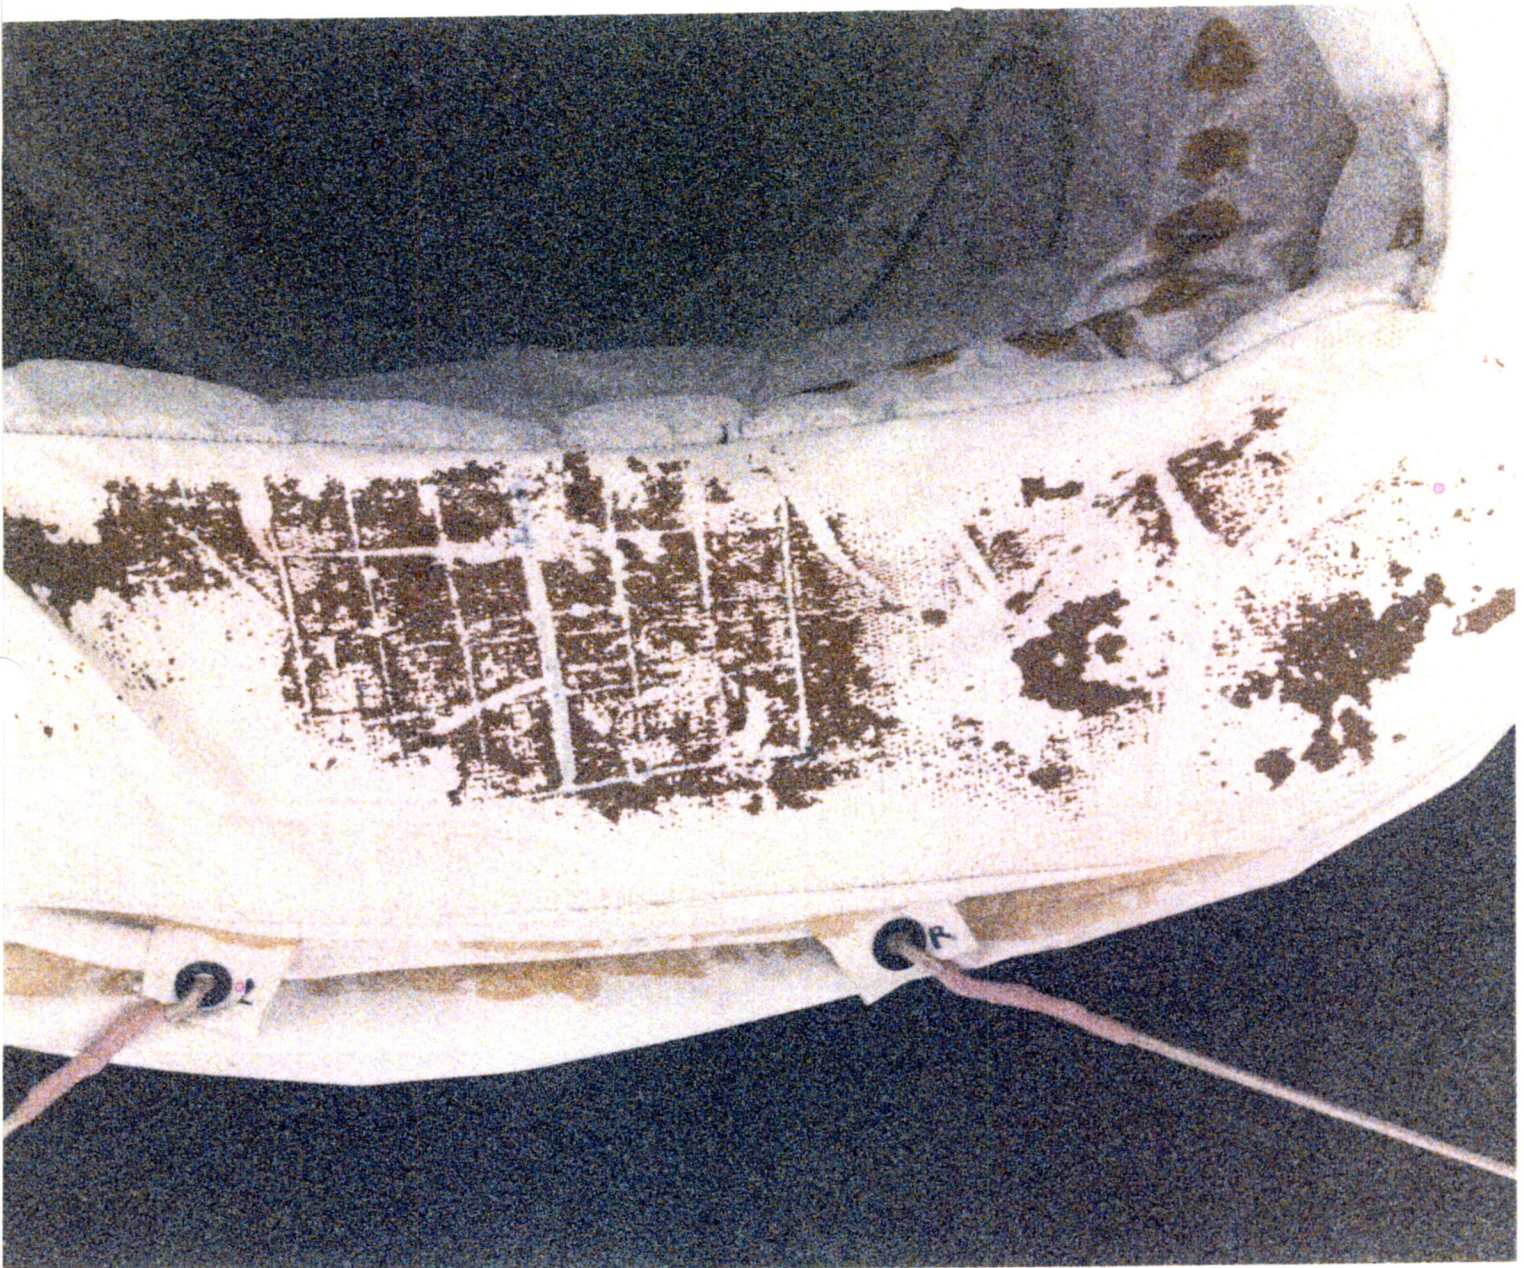
**Photo 8 : Topcoat Adhered to -Y GOX Vent Seal**

Topcoat adhered to GOX vent seals and was subsequently pulled up from the ET nose cone footprint area during GOX hood retraction. Post drain inspection found the missing topcoat, but no TPS, adhering to both GOX vent seals.

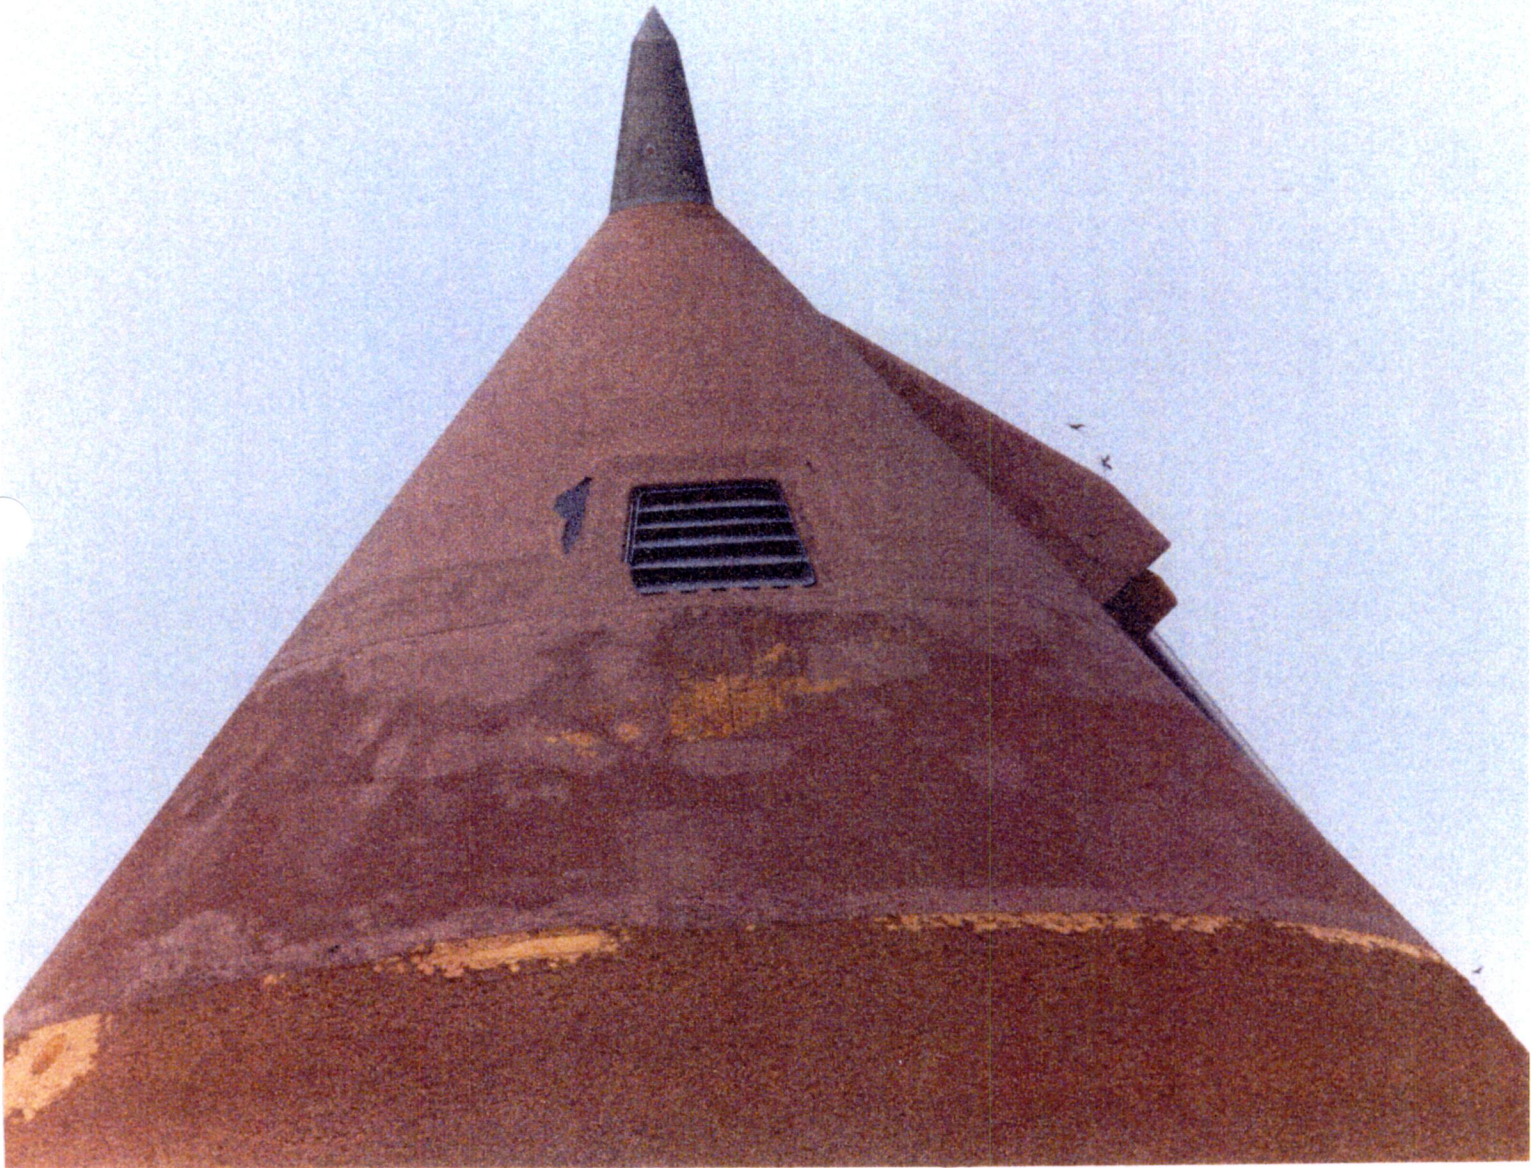
**Photo 9 : ET Nose Cone/Footprint Area**

Loose topcoat had been removed during the scrub turnaround. Missing topcoat from the nose cone footprint area and around the louver was a condition accepted for flight.

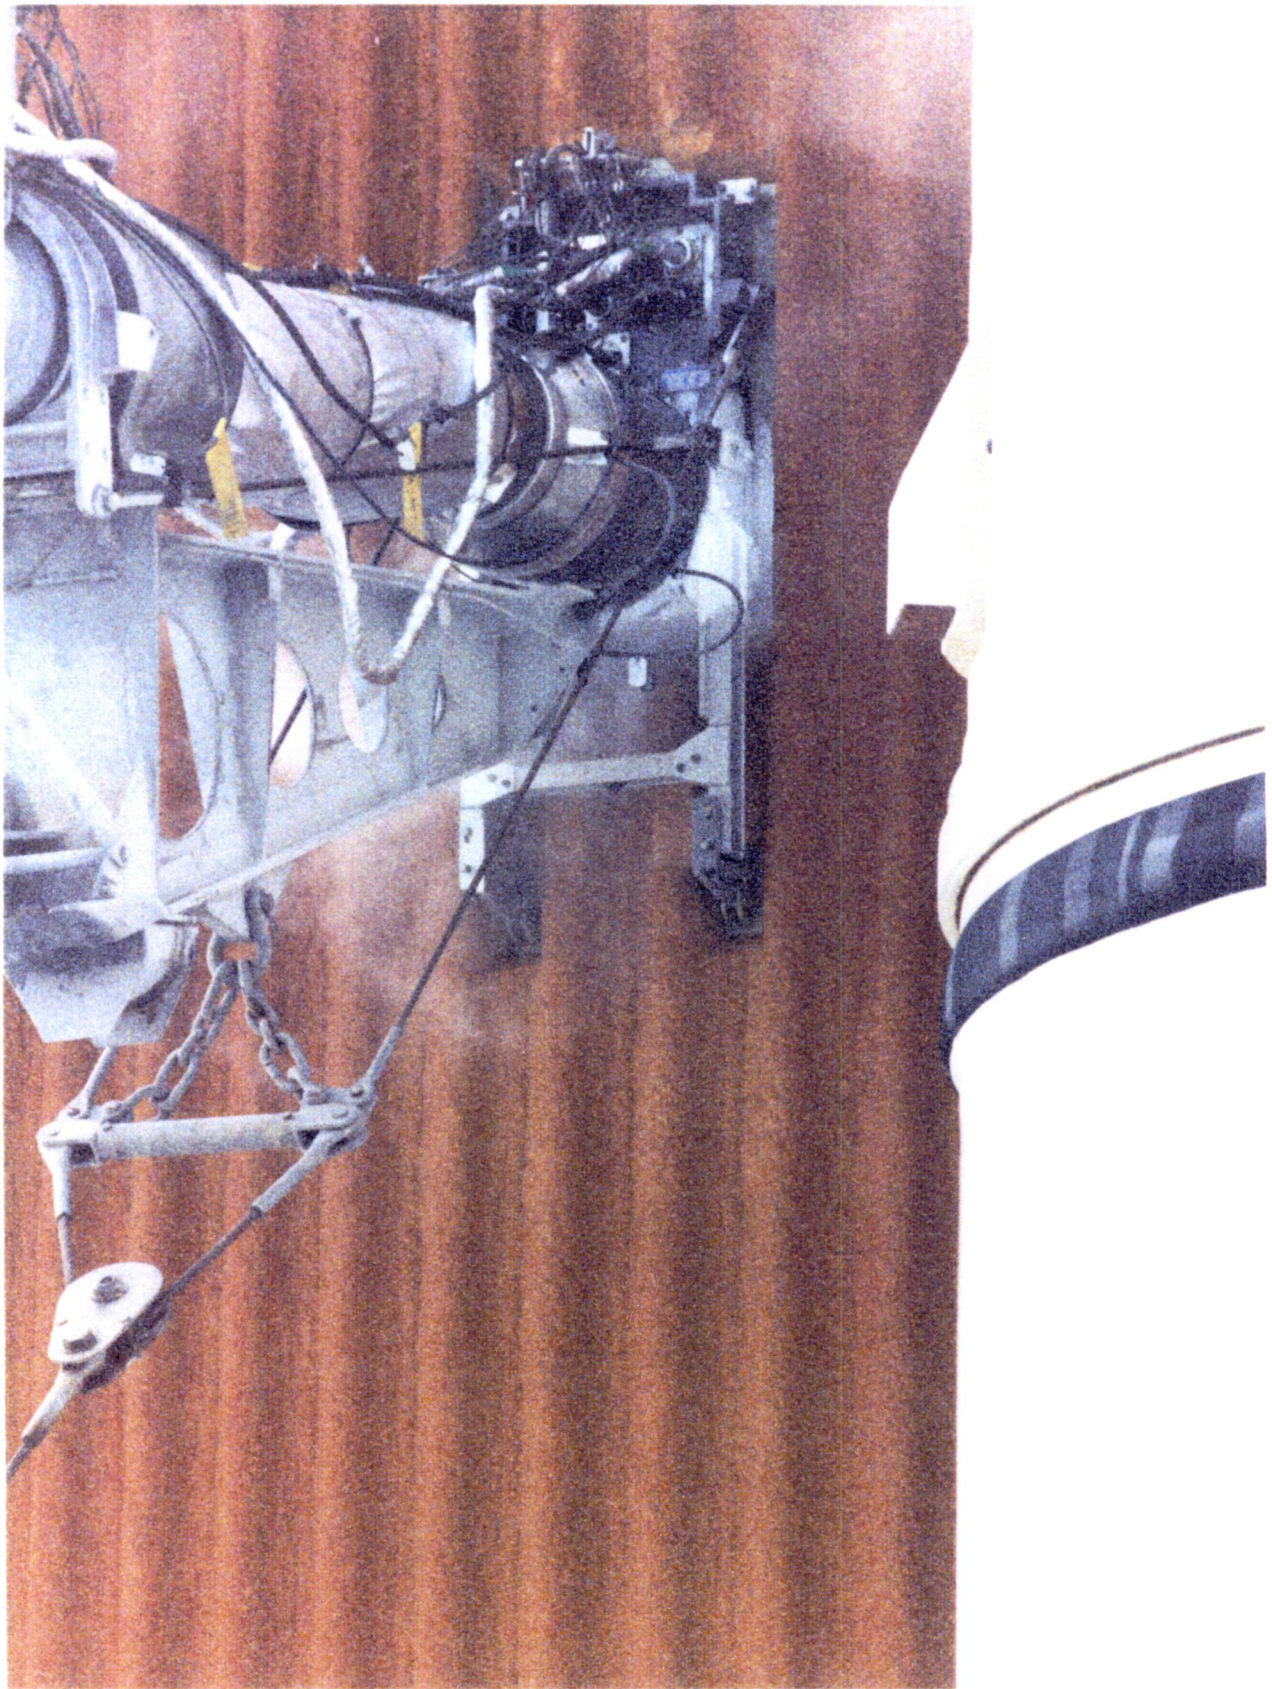
**Photo 10: Liquid Air/Ice Formations on GUCP**

The intertank acreage exhibited no TPS anomalies. More than usual ice/frost formations and venting vapors were present around the ET umbilical carrier plate. Liquid air drips seemed to originate from the ice suppression shroud area during cryoload, but stopped after ice and frost accumulated to form an ice insulation. The leak detectors gave no indication of an internal leak.

More than usual ice/frost formations and venting vapors were present around the ET umbilical carrier plate. Liquid air drips seemed to originate from the ice suppression shroud area during cryoload, but stopped after ice and frost accumulated to form an ice insulation. The leak detectors gave no indication of an internal leak.

There was no visible damage to the GUCP or QD that may have contributed to the heavier-than-usual formation of ice/frost along with venting vapors and liquid air drops observed during cryo load. The seals were inspected closely during GUCP disassembly. All mechanical interfaces and bolts were checked. No cause for the liquid air drops was found.

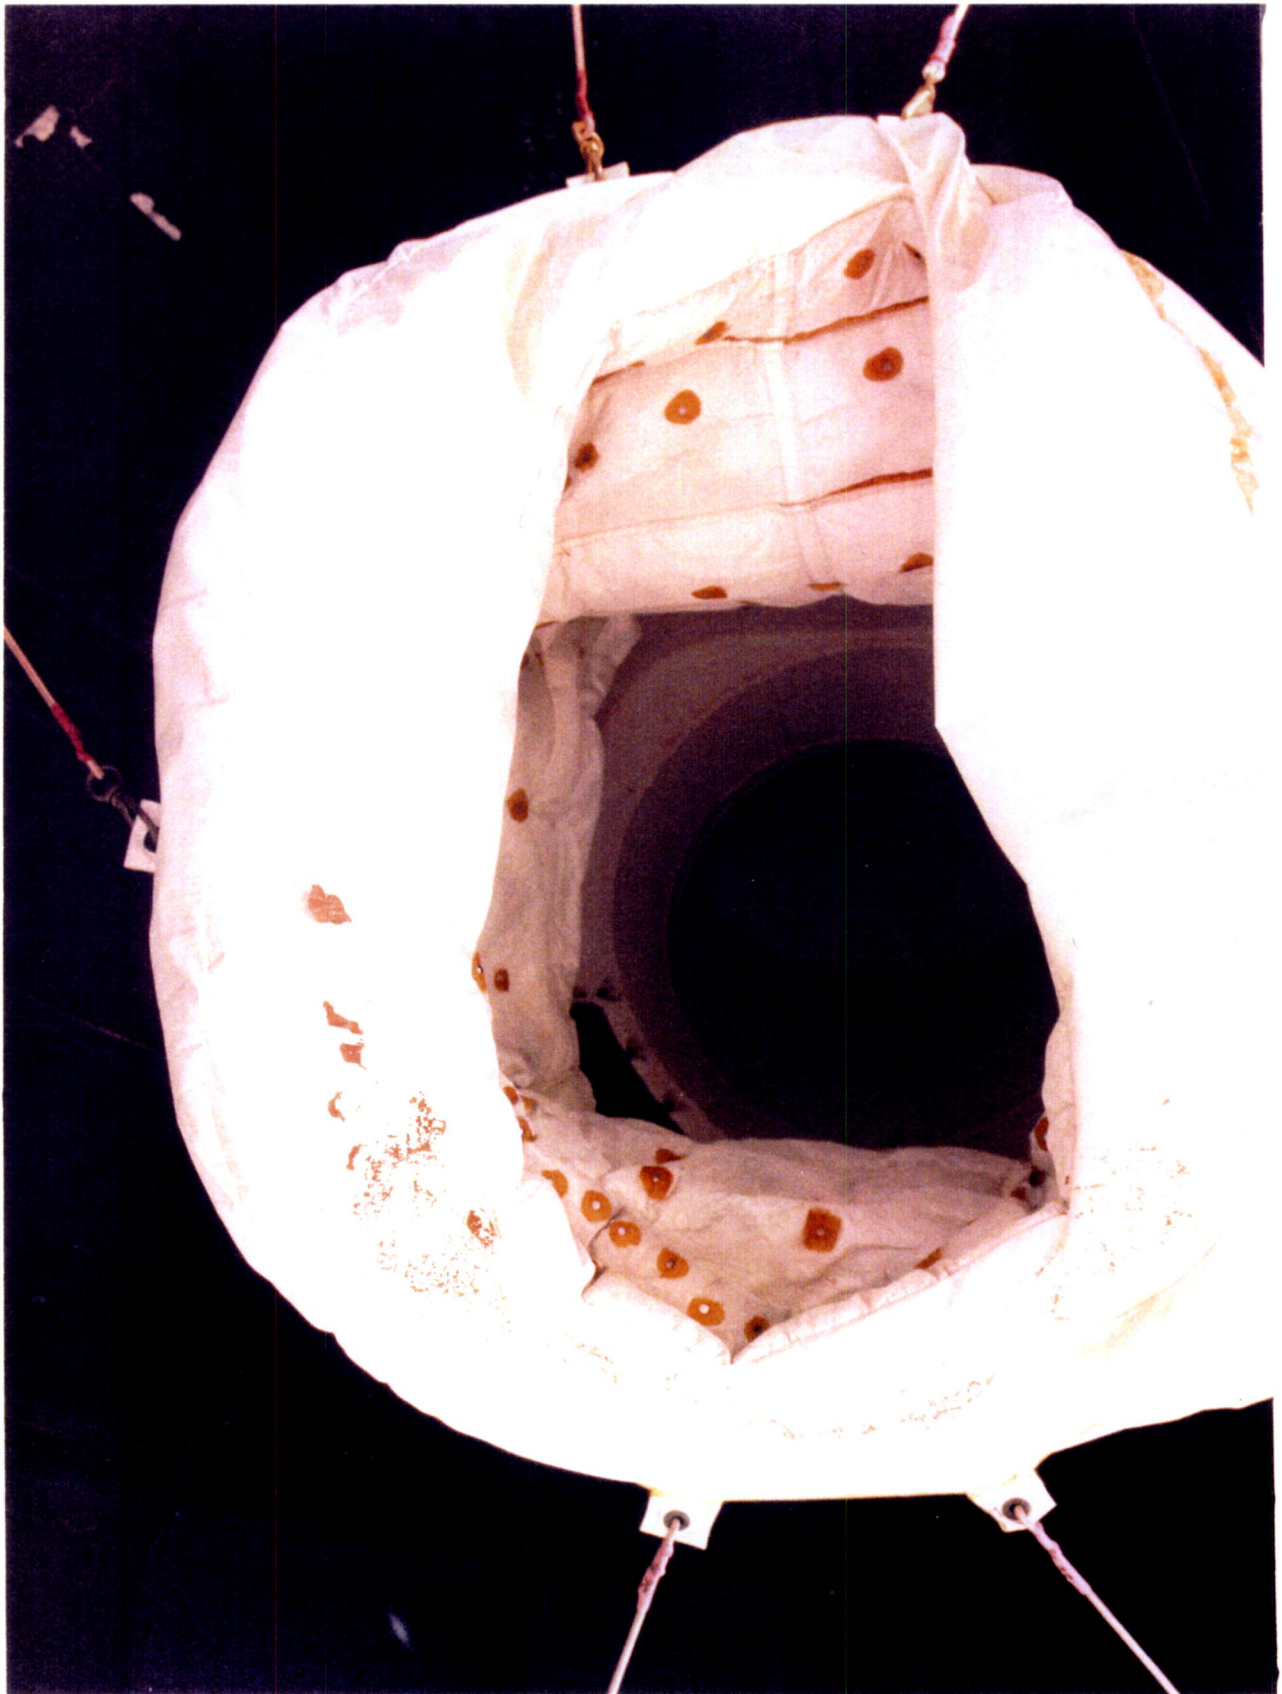
**Photo 12: Nose Cone Topcoat Adhered to GOX Vent Seal**

The seals stuck momentarily to the ET nose cone during GOX vent hood retraction at T-2:30 minutes. Nose cone foam insulation was not damaged.

Both northeast and southwest GOX vent seals stuck momentarily to the External Tank nosecone topcoat during seal deflation/retraction at T-2:30. Numerous small pieces of topcoat were pulled loose from both footprint areas and adhered to the seals. This condition was acceptable for launch. Residual GOX vapors vented from the frost-coated ET northeast louver. MPS vibration caused four pieces of frost to fall away from the louver. The External Tank "twanged" approximately 32 inches during SSME ignition (E-79; OTV 060, 061).

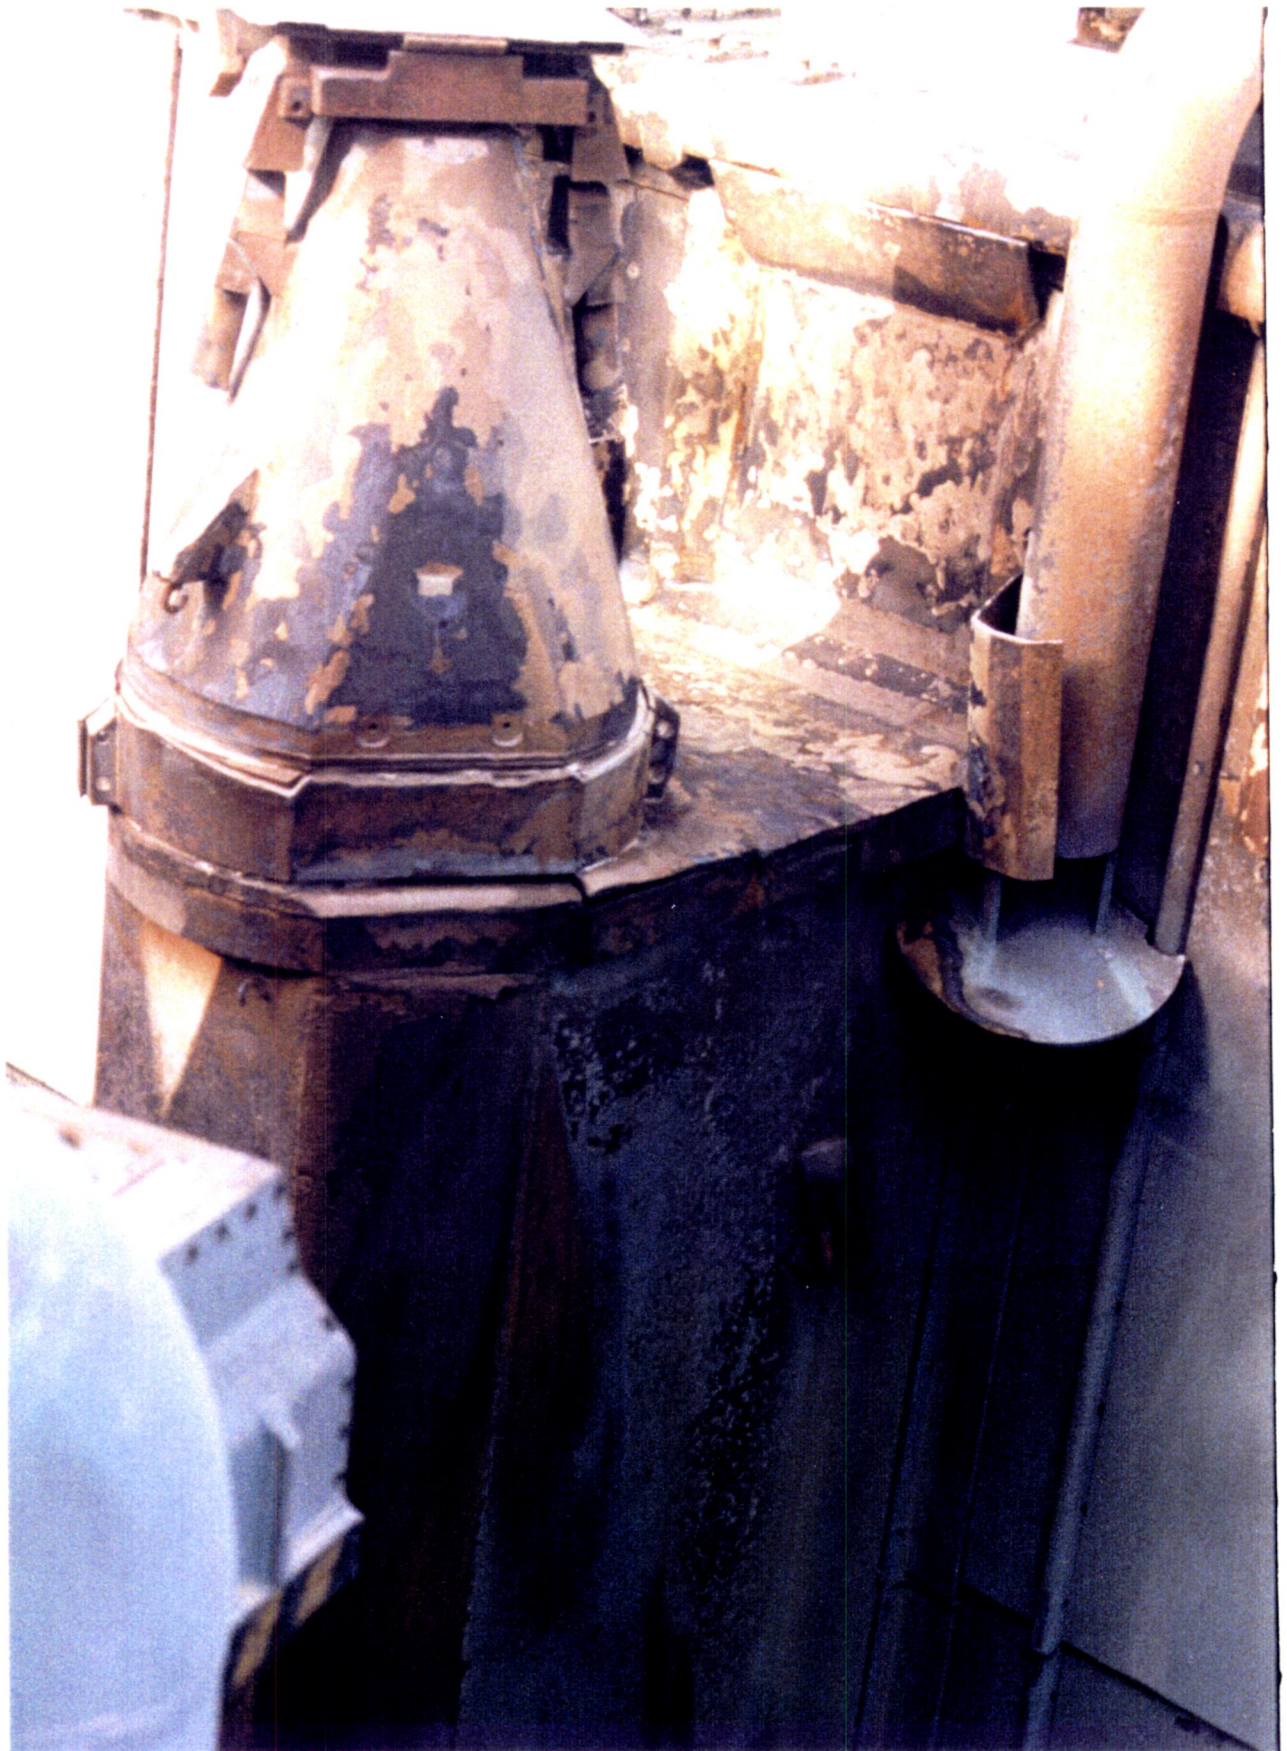
**Photo 13: Holddown Post Sacrificial Plate Crack**

A 2-foot long crack in the HDP #4 sacrificial plate was offset by a half inch.

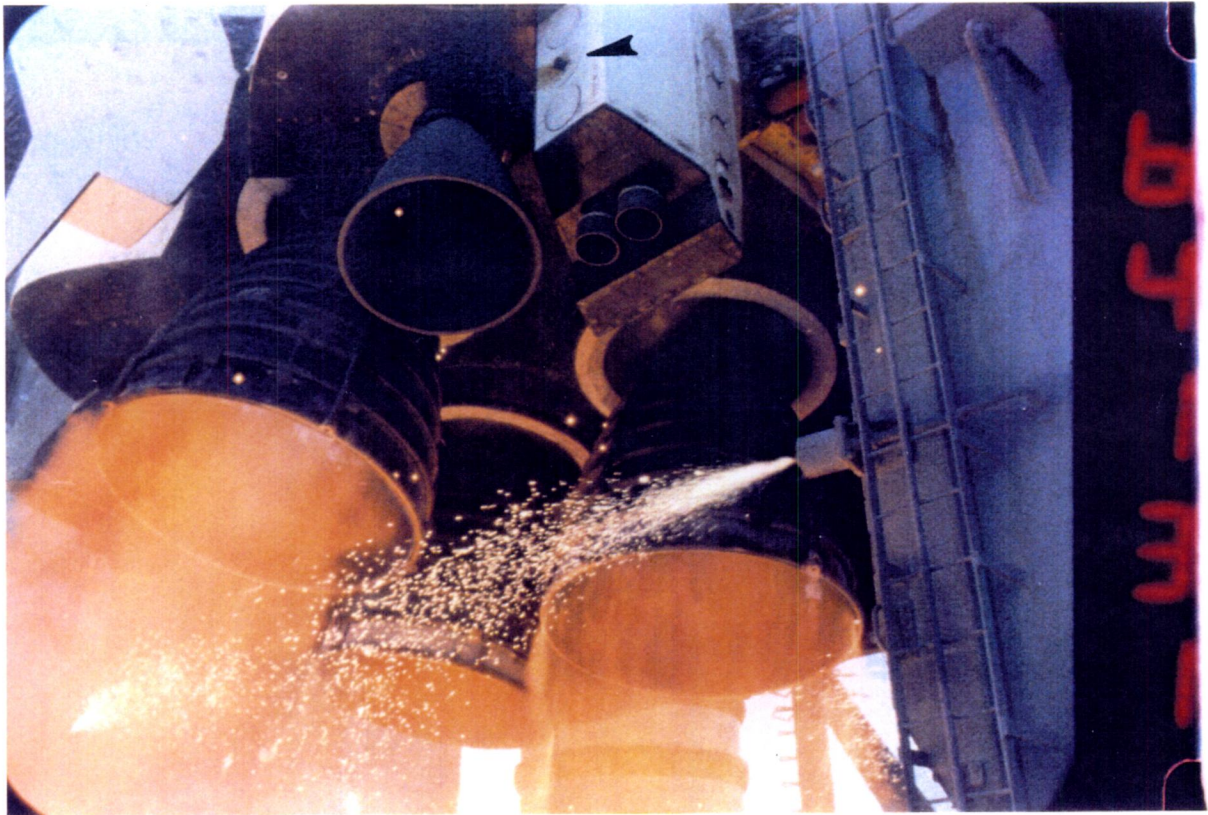
**Photo 14: Vapors from Aft RCS Thruster**

Oxidizer vapors exited aft RCS thruster R2U as the paper cover ruptured during SSME ignition. This thruster had exhibited signs of a very small leak prior to launch.

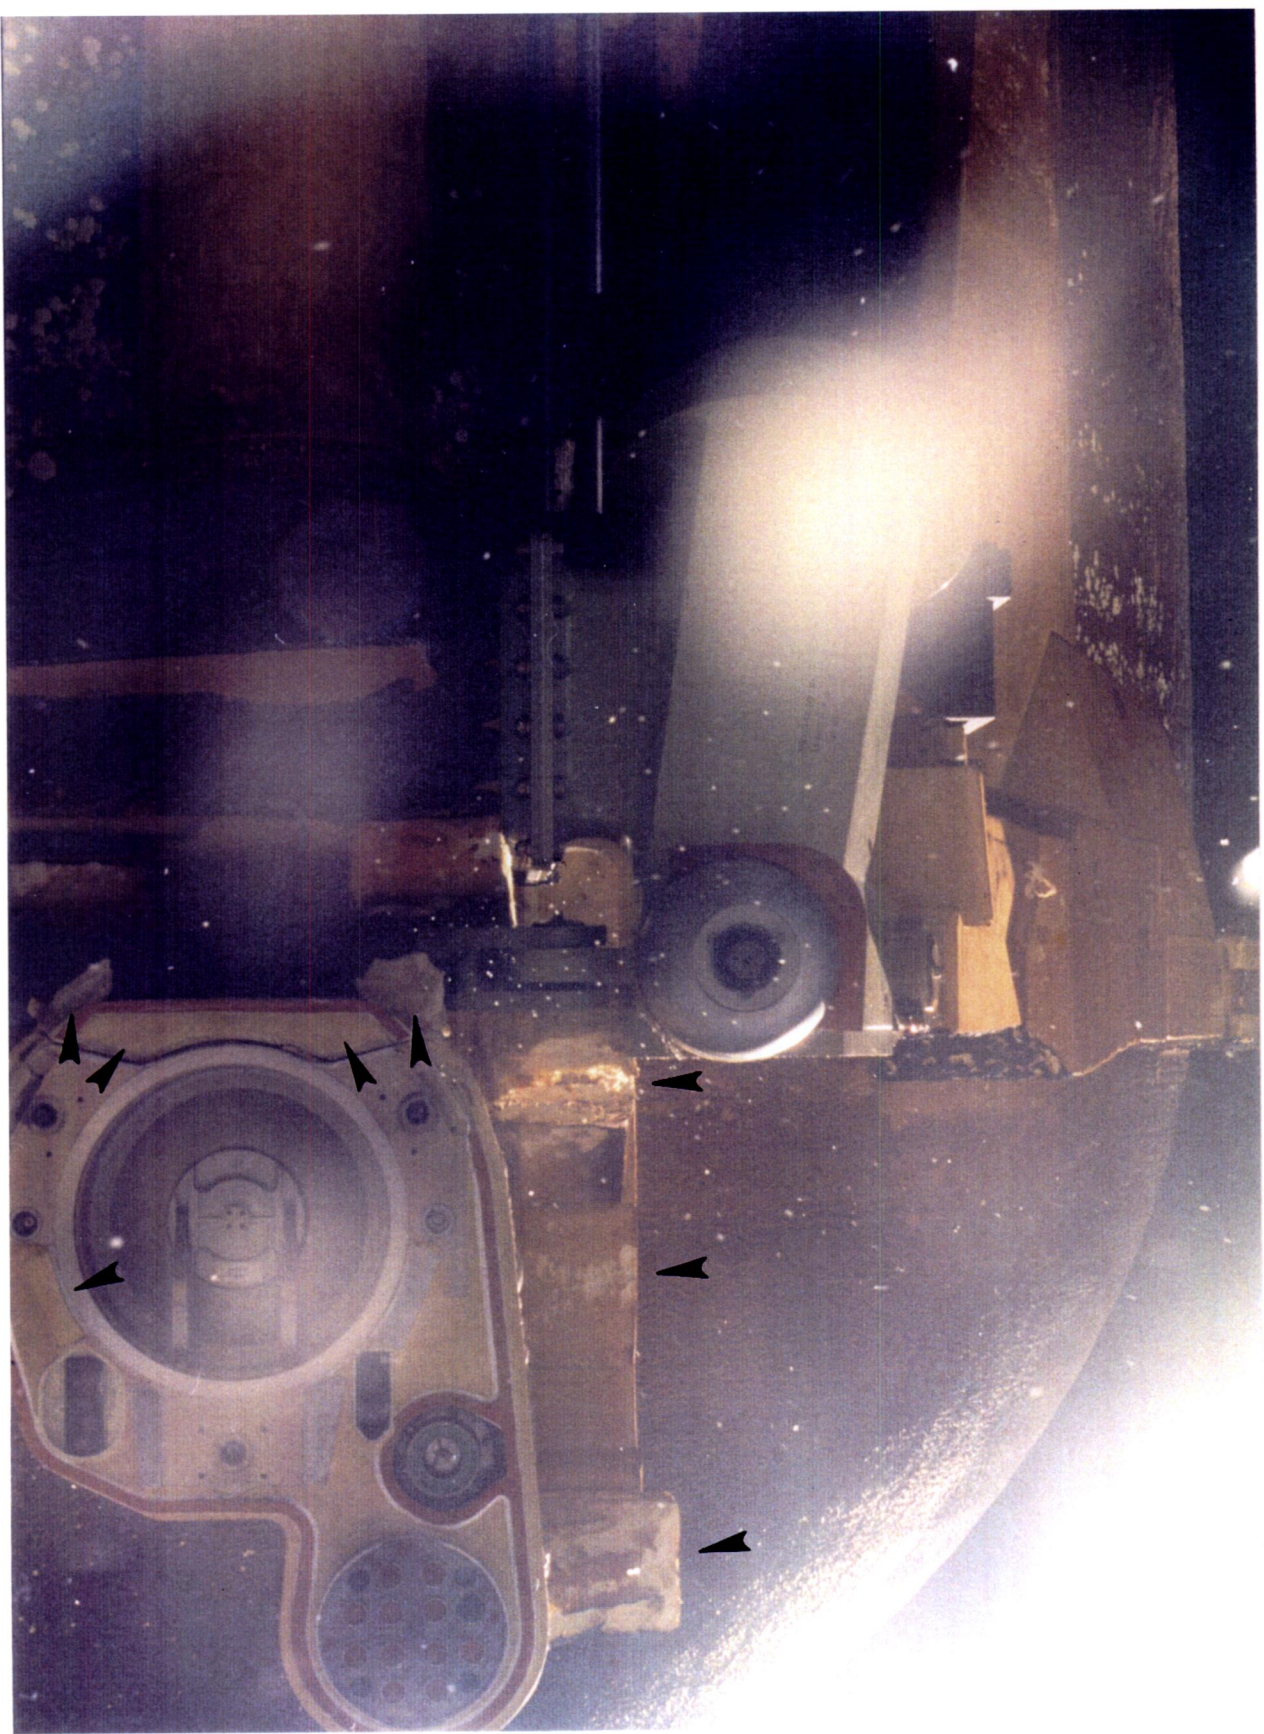
**Photo 17: LO2 ET/ORB Umbilical After ET Separation**

The LO2 ET/ORB umbilical sustained TPS damage at both inboard and outboard forward corners. Numerous divots and eroded areas were visible on the horizontal and vertical sections of the cable tray. Some of the divots spanned the full width of the cable tray. Lightning contact strips across the forward part of the umbilical and at the 8 o'clock position were missing. Loss of lightning contact strips was also the subject of a previous IFA.

The LO2 ET/ORB umbilical sustained TPS damage at both inboard and outboard forward corners. Numerous divots and eroded areas were visible on the horizontal and vertical sections of the cable tray. Lightning contact strips across the forward part of the umbilical and at the 8 o'clock position were missing. Loss of lightning contact strips were the subject of a previous IFA.
